Home Report

Scottish Single Survey

Property address	3/1 2 Ardessie Street Glasgow G23 5HX
Customer	Claire Smith
Customer address	3/1 2 Ardessie Street Glasgow G23 5HX
Prepared by	Shepherd Chartered Surveyors
Date of inspection	02/04/2024

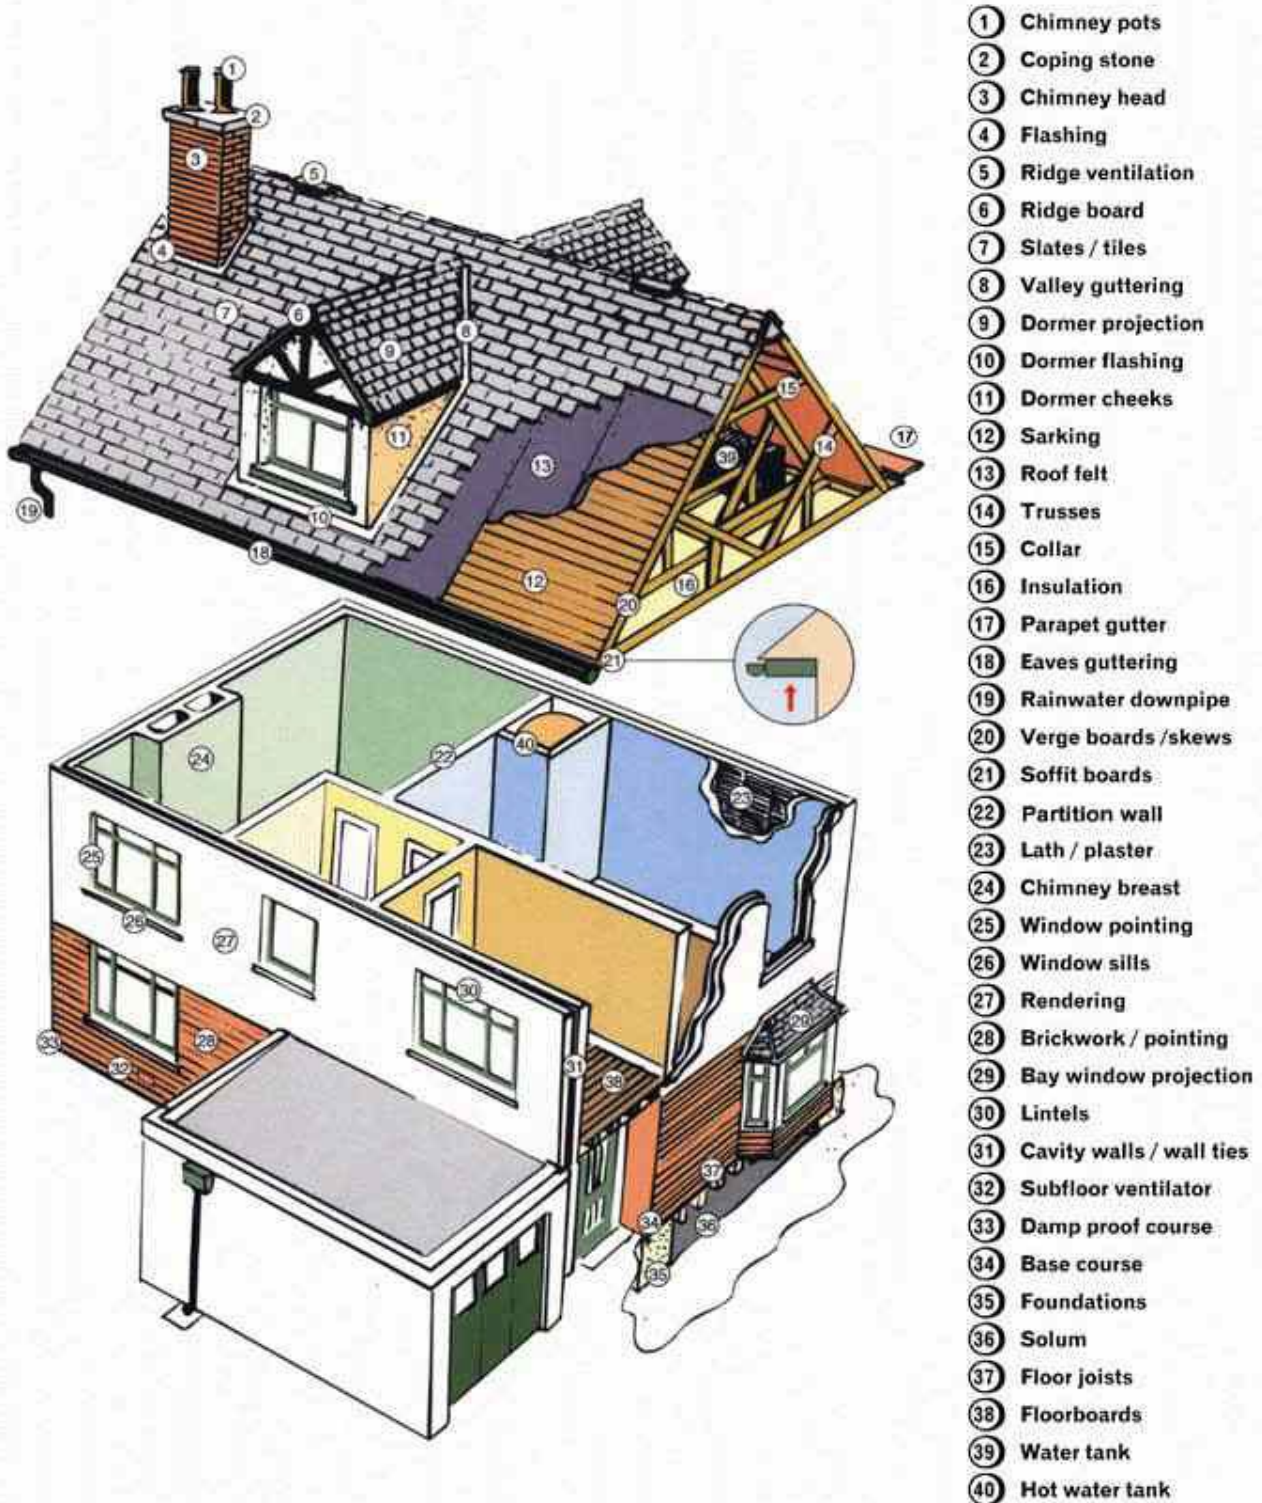
Sectional Diagram showing elements of a typical house

- ① Chimney pots
- ② Coping stone
- ③ Chimney head
- ④ Flashing
- ⑤ Ridge ventilation
- ⑥ Ridge board
- ⑦ Slates / tiles
- ⑧ Valley guttering
- ⑨ Dormer projection
- ⑩ Dormer flashing
- ⑪ Dormer cheeks
- ⑫ Sarking
- ⑬ Roof felt
- ⑭ Trusses
- ⑮ Collar
- ⑯ Insulation
- ⑰ Parapet gutter
- ⑱ Eaves guttering
- ⑲ Rainwater downpipe
- ⑳ Verge boards /skews
- ㉑ Soffit boards
- ㉒ Partition wall
- ㉓ Lath / plaster
- ㉔ Chimney breast
- ㉕ Window pointing
- ㉖ Window sills
- ㉗ Rendering
- ㉘ Brickwork / pointing
- ㉙ Bay window projection
- ㉚ Lintels
- ㉛ Cavity walls / wall ties
- ㉜ Subfloor ventilator
- ㉝ Damp proof course
- ㉞ Base course
- ㉟ Foundations
- ㊱ Solum
- ㊲ Floor joists
- ㊳ Floorboards
- ㊴ Water tank
- ㊵ Hot water tank

Reference may be made in this report to some or all of the above component parts of the property. This diagram may assist you in locating and understanding these items.
