# Home Report

# Scottish Single Survey

<b>Property address</b>	4/1 7 Centurion Way Glasgow G3 8NX
-------------------------	---

<b>Prepared by</b>	Shepherd Chartered Surveyors
--------------------	------------------------------

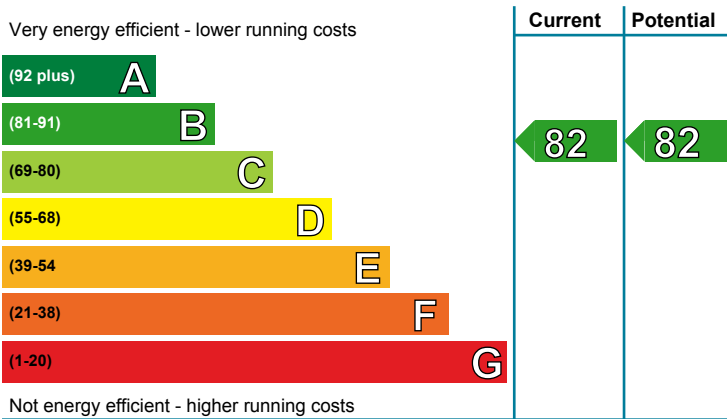
## Energy Efficiency Rating

This graph shows the current efficiency of your home, taking into account both energy efficiency and fuel costs. The higher this rating, the lower your fuel bills are likely to be.

Your current rating is **band B (82)**. The average rating for EPCs in Scotland is **band D (61)**.

The potential rating shows the effect of undertaking all of the improvement measures listed within your recommendations report.

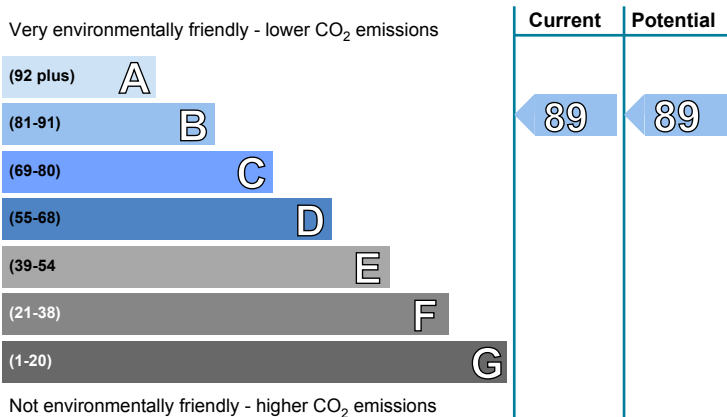
## Environmental Impact (CO<sub>2</sub>) Rating

This graph shows the effect of your home on the environment in terms of carbon dioxide (CO<sub>2</sub>) emissions. The higher the rating, the less impact it has on the environment.
