**HOME**  
report

# Single Survey

<b>Property Address</b>	Flat 2 75 Lancefield Quay Glasgow G3 8HA
<b>Customer</b>	Mr V Bardarski
<b>Date of Inspection</b>	20/03/2024
<b>Prepared by</b>	Alan Weir Harvey Donaldson & Gibson Chartered Surveyors

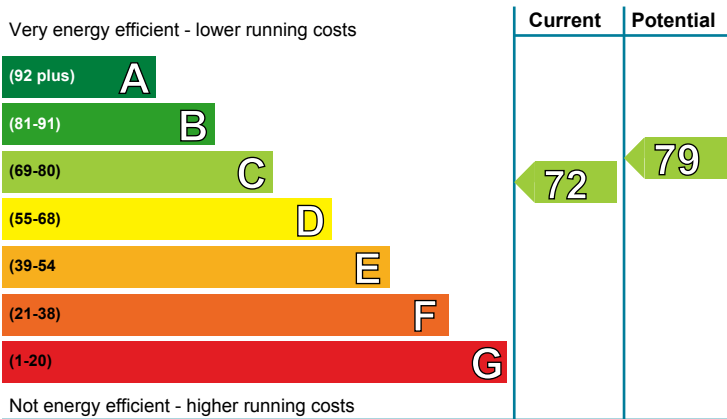
## Energy Efficiency Rating

This graph shows the current efficiency of your home, taking into account both energy efficiency and fuel costs. The higher this rating, the lower your fuel bills are likely to be.

Your current rating is **band C (72)**. The average rating for EPCs in Scotland is **band D (61)**.

The potential rating shows the effect of undertaking all of the improvement measures listed within your recommendations report.
